HOCKANUM RIVER BASIN  
MANCHESTER, CONNECTICUT

PORTER RESERVOIR DAM  
CT 00014

PHASE I INSPECTION REPORT  
NATIONAL DAM INSPECTION PROGRAM

MAY 1980

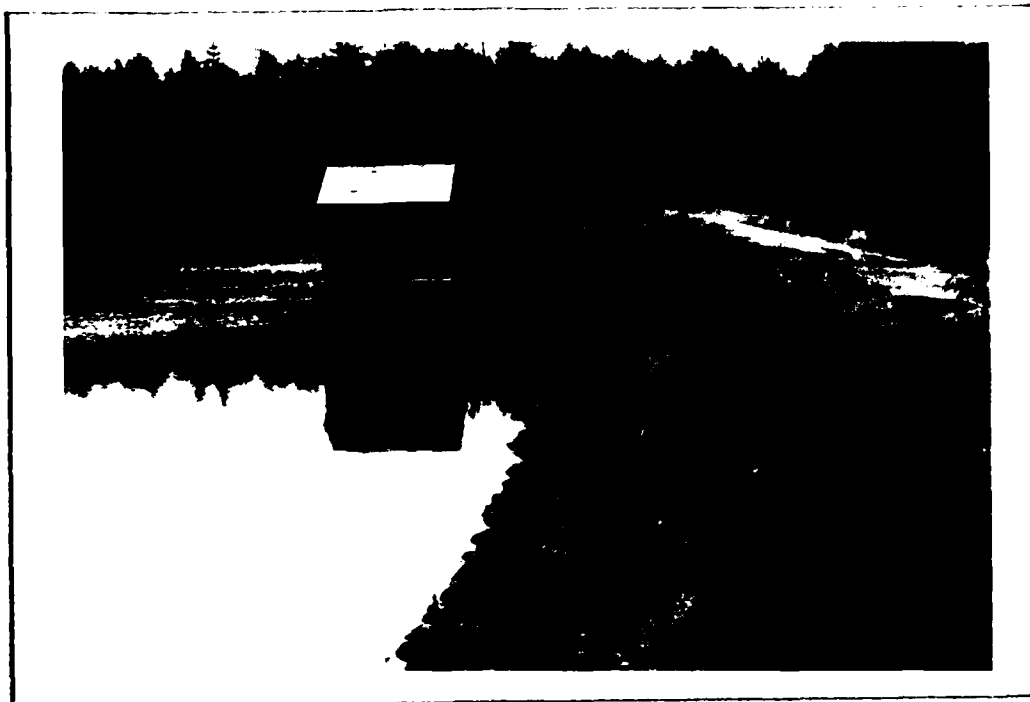
1. DETAILS OF THE UPSTREAM FACE AND TOP FACE OF THE DAM WITH THE GATEHOUSE AND CATWALK IN THE BACKGROUND. (11/14/79)

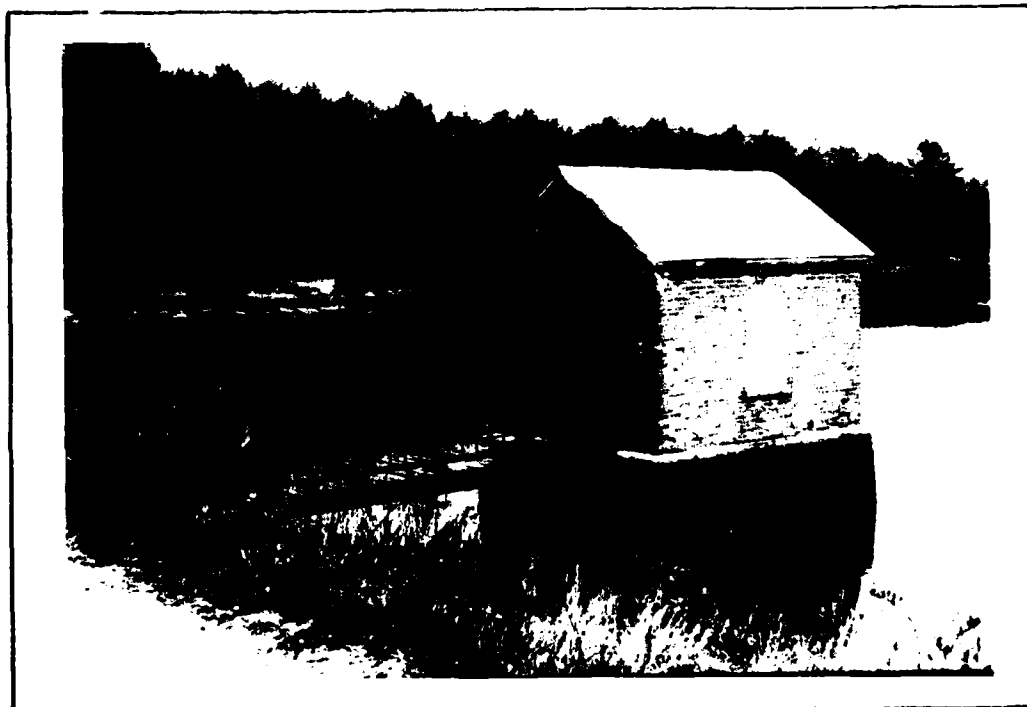
c. Appurtenant Structures. The masonry gatehouse and access bridge appeared to be in fair condition at the time of the inspection. The only deficiencies observed were cracks in the mortar between stone blocks near the water level.

2. GATEHOUSE AND CATWALK WITH THE RIGHT SHORELINE IN THE BACKGROUND. (11/14/79)

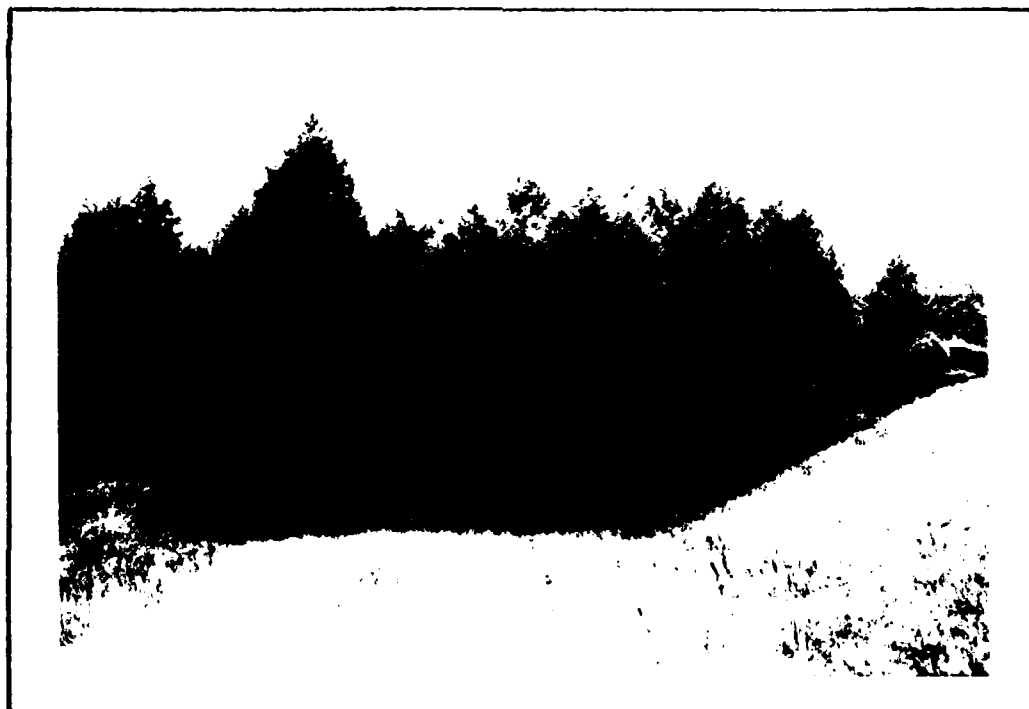
3. The root systems of trees which are growing on the downstream face, at the downstream toe, and in the vicinity of the abutments present potential hazards to the structural integrity of the embankment. The roots could create seepage paths through the embankment and, in the event of uprooting, could remove significant portions of the embankment.

4. HEAVY TREE COVER ON THE DOWNSTREAM FACE OF THE DAM.  
(11/14/79)

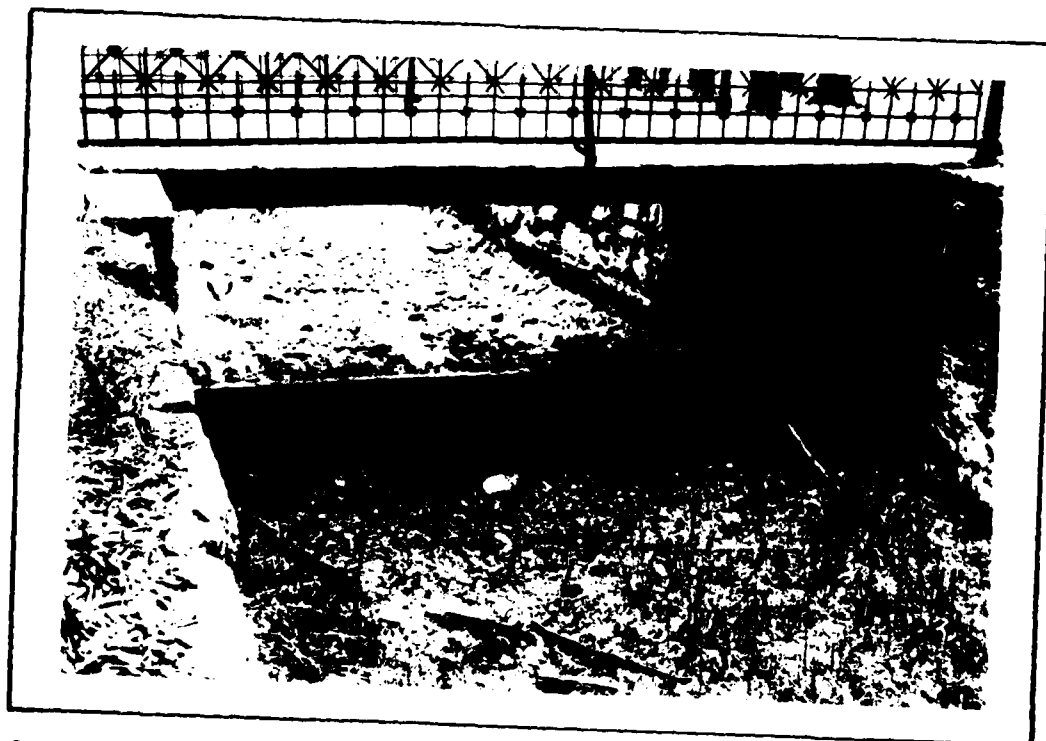
A few loose stones were noted in the masonry spillway training walls. The concrete weir appears to be in good condition and the channel is kept relatively free of debris by a log boom located at the spillway inlet.

8. WEIR IN THE "WASTEWATER" SPILLWAY CHANNEL ABOUT 75 FEET DOWNSTREAM FROM THE RESERVOIR. (11/14/79)

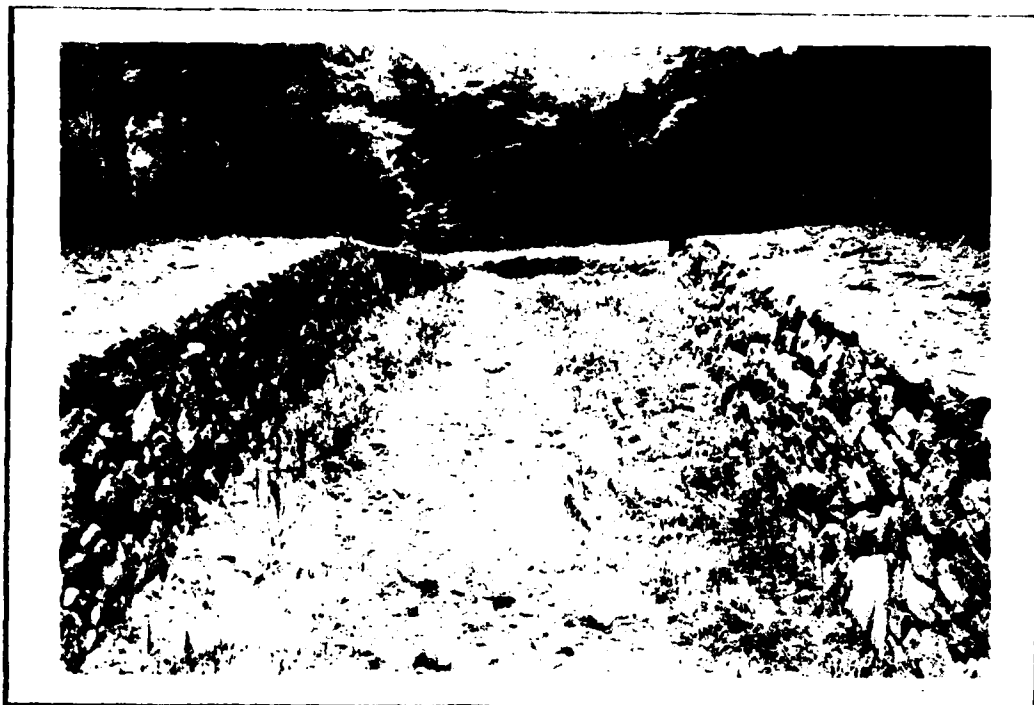
9. "WASTEWATER" SPILLWAY OUTLET CHANNEL AS VIEWED FROM THE BRIDGE OVER THE CHANNEL. (11/14/79)

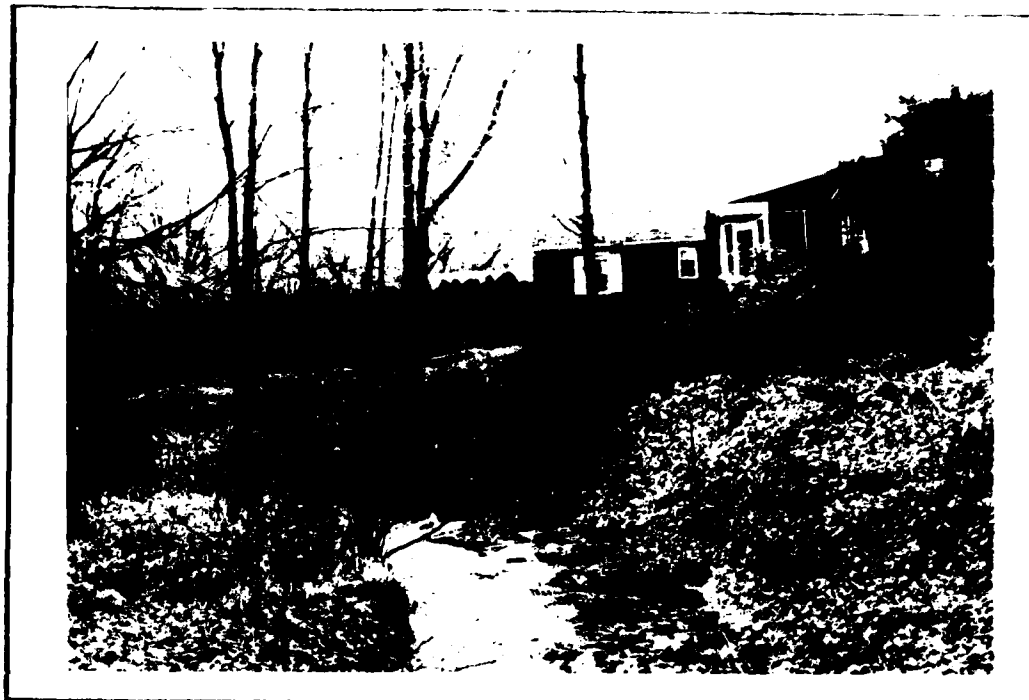
11. POTENTIAL DAMAGE AREA ONE HALF MILE DOWNSTREAM  
FROM THE DAM. (11/14/79)

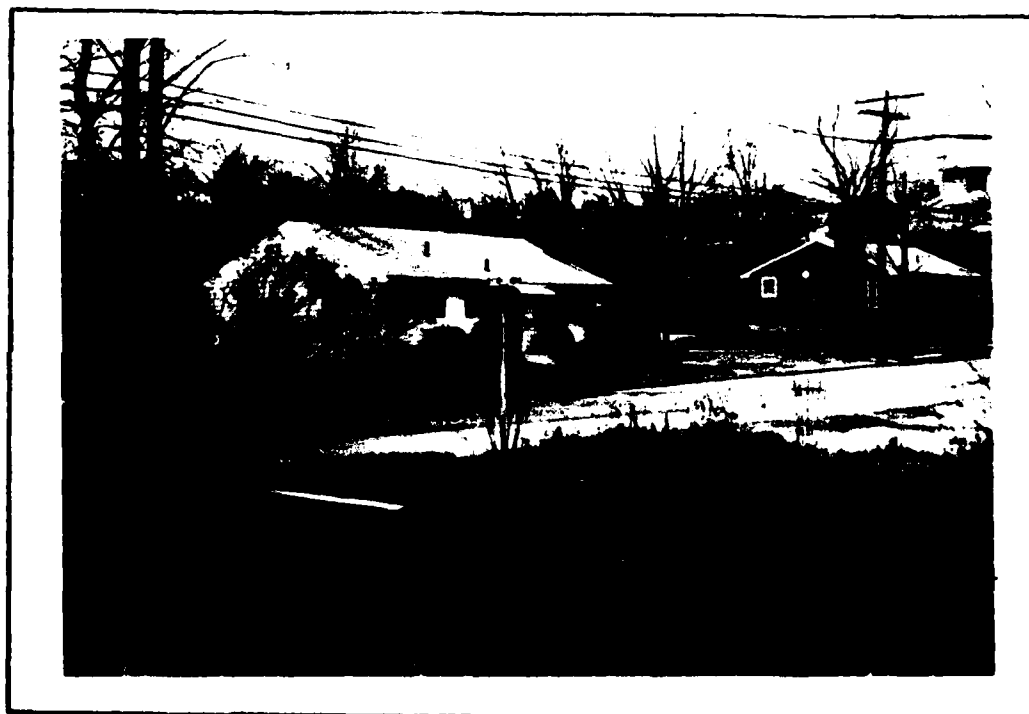
14. POTENTIAL DAMAGE AREA 1.2 MILES DOWNSTREAM FROM THE DAM. (11/14/79)
